**Flood Control Project Maintenance
Levee Inspections**

Maintenance Issue Types Only, Levee Inspection Report By Mile - Fall 2014

Madera County FCWCA

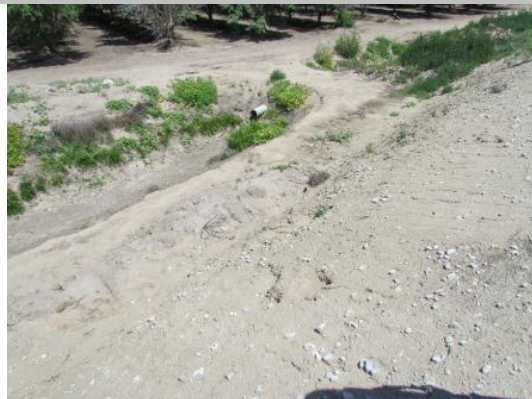
Photo 1 of 1 : FA_2014_NA0011_142_20_20141008_00007.jpg

| Repair slope instability. Inspector Comments: This is not a new erosion site, it should be repaired before the condition get any worse. | | | | | |

The landside levee slope and toe has some damage noted during this inspection. Photo taken 4-29-2014. No new photo was taken during this Fall inspection.

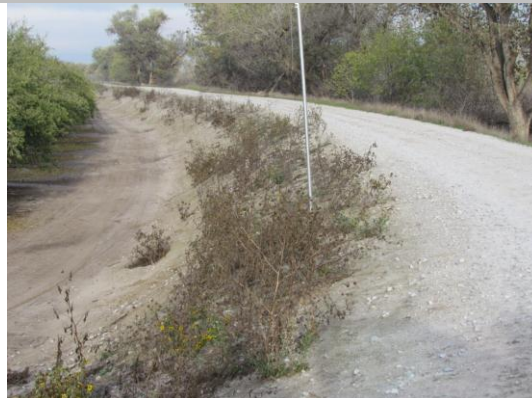
Photo 1 of 1 : FA_2014_NA0011_142_37_20141124_00020.jpg

| Control annual grass and weeds on the levee slopes and easements. Inspector Comments: Remove the tall weeds from the levee section. | | | | | |

Tall weeds on levee shoulder and slope from 0.24 to 1.26.

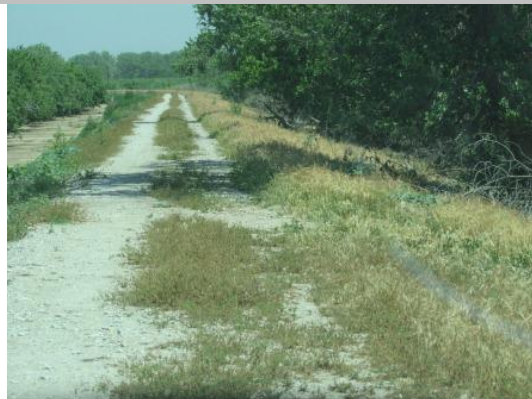
Photo 1 of 2 : FA_2014_NA0011_142_24_20141008_00008.jpg

| Keep the crown roadway free of vegetation. Inspector Comments: The levee crown roadway should be free from any vegetation. | | | | | |

The levee crown roadway is overgrown with weeds. Photo taken 4-29-2014.

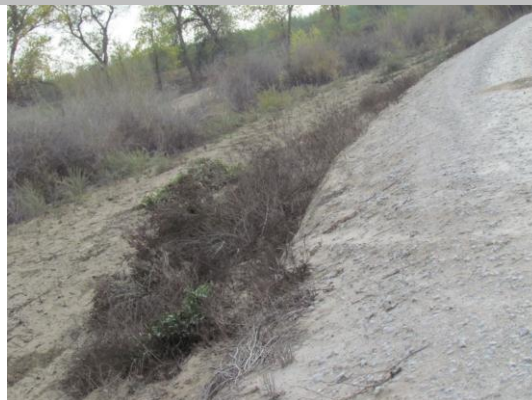
Photo 1 of 1 : FA_2014_NA0011_142_33_20141121_00014.jpg

| Repair slope instability. Inspector Comments: The toe here has been damaged by farm equipment. | | | | | |

Looking downstream from levee mile 1.06 toward levee mile 1.24 at the waterward toe that has been damaged.

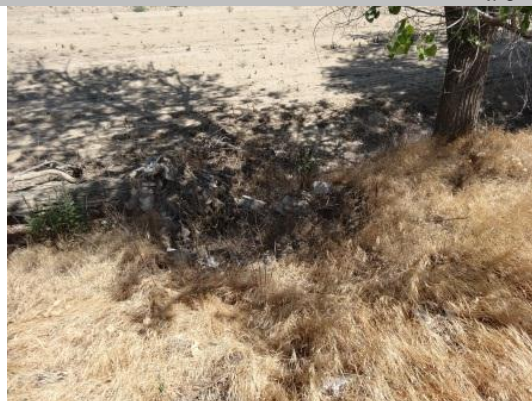
Photo 1 of 1 : SJR2014_NA0011U01RM2.57_1.jpg

Inspector Comments: 07/22/2014: No significant change observed.
08/30/2013: No significant change observed.
07/31/2012: Site was visited on 07/24/2012. No significant change observed. Dense vegetation around the site
08/09/2011: Site was inspected. No visible change was observed from the previous condition. A fallen tree was seen at the levee toe about 20 feet upstream, and tree root exposed. There has been no report from the district that this site was corrected.
11/30/2010: Site was not inspected due to time constraints. There have been no reports from the district that the site was corrected. Continue to monitor site during flood events.
08/05/2010: Recommended for annual assessment and monitoring during flood events, per CLRO.
2009: Site is recommended as a local maintenance issue, per Critical Levee Repair Office, Critical Erosion Sites Evaluation 2008 Report; site was previously rated "M"

9/6/2007: Undercutting of the toe; several trees along the WS slope with roots exposed. [2014 Site ID:NA0011U01RM2.57]

View of the erosion site from the levee crest.

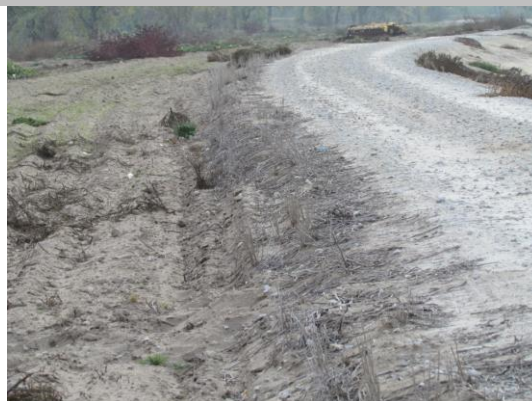
Photo 1 of 1 : FA_2014_NA0011_142_32_20141121_00013.jpg

| Repair slope instability. Inspector Comments: The toe has been damaged by discing too close to the levee toe waterward. | | | | | |

Looking downstream water ward slope damaged by discing equipment.

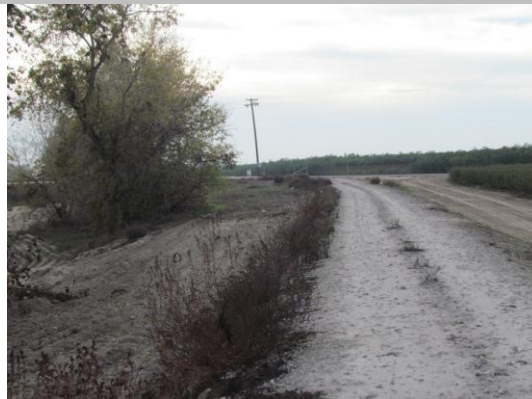
Photo 1 of 1 : FA_2014_NA0011_142_26_20141121_00012.jpg

| Control annual grass and weeds on the levee slopes and easements. Inspector Comments: Remove the unwanted tall weeds from the waterward shoulder and slope. | | | | | |

Unwanted tall weeds on the waterward slope.

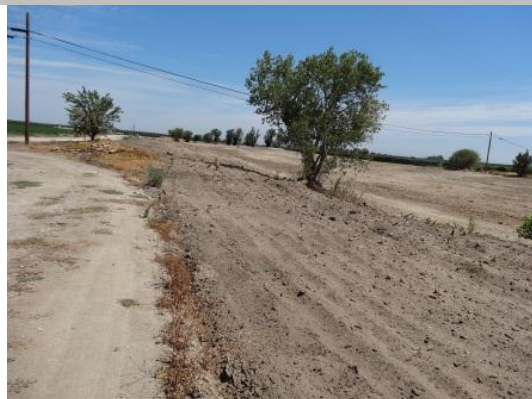
Photo 1 of 1 : SJR2014_NA0011U01RM3.8_1.jpg

| Inspector Comments: 07/22/2014: No significant change observed. 08/30/2013: No significant change observed 07/31/2012: Site was visited on 07/26/2012. No significant change observed 08/09/2011: Site was inspected. No visible change was observed from the previous condition. There have been no reports from the district that this site was corrected. 11/30/2010: Site was not inspected this year due to time constraints. There have been no reports from the district that this site was corrected. Continue monitor during flood events. 08/05/2010: Recommended for annual assessment and monitoring during flood events, per CLRO. 2009: Site is recommended as a local maintenance issue, per CLRO CES Evaluation 2008 Report; it was previously rated "M". 8/26/2008: Undulating waterside slope surface; vehicular damage along the waterside slope possibly caused by farming equipment; levee crown is composed of sandy material; there is a collection of concrete rubble on the waterside crown hinge; vehicular damage extends from levee toe to crown surface. 9/6/2007: Farmer degraded levee on water-ward slope and crown. [2014 Site ID:NA0011U01RM3.8] | | | | | |

Close view of the site. The site has been plowed by the farm vehicle and the erosion is not visible any longer.

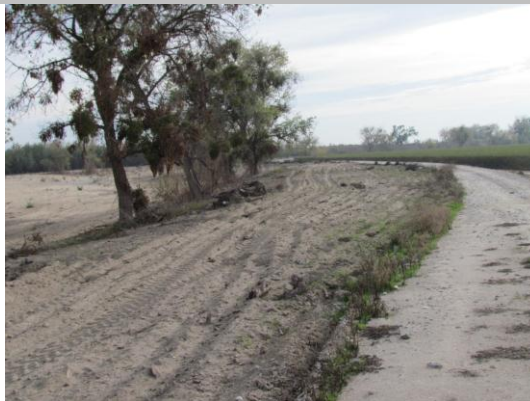
Photo 1 of 1 : FA_2014_NA0011_142_17_20141124_00016.jpg

| Repair slope instability. Inspector Comments: The farmer has plowed up the waterside berm too close to the levee toe causing damage to the levee toe also this method transfers the bamboo roots along the berm. Spraying is needed to kill the new growth. This method of maintaining the waterside cannot continue. | | | | | |

Ash Slough levee toe damaged by farm equipment discing too close.

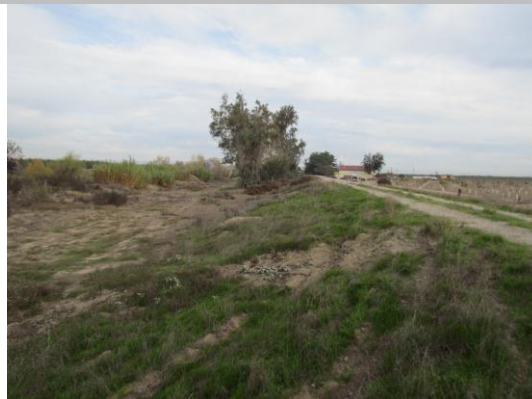
Photo 1 of 1 : FA_2014_NA0011_143_33_20141124_00011.jpg

| Inspector Comments: Remove the wild weeds from the waterside levee slope. | | | | | |

Looking upstream from the waterside slope at tall weeds present on the levee section.

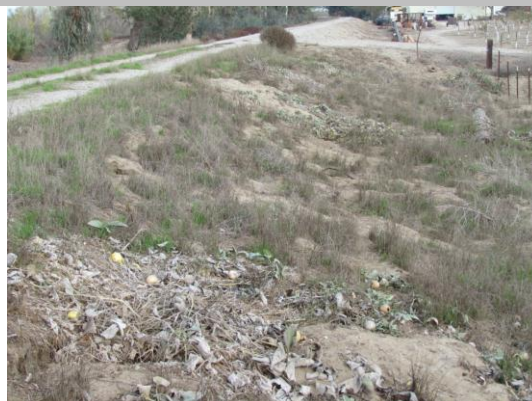
Photo 1 of 1 : FA_2014_NA0011_143_39_20141124_00014.jpg

| Control annual grass and weeds on the levee slopes and easements. Inspector Comments: Wild growth on levee slope need to be removed. | | | | | |

Looking upstream from 0.00 at wild growth on the landside levee slope.

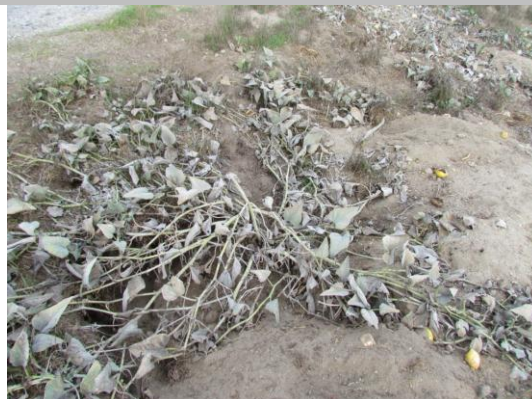
Photo 1 of 1 : FA_2014_NA0011_143_19_20141124_00013.jpg

| Exterminate rodents and backfill and compact or grout burrows. Inspector Comments: The rodents here on the landside need to be controlled. Bait stations are needed. | | | | | |

Large rodent mounds underneath vine growth on the landside slope.

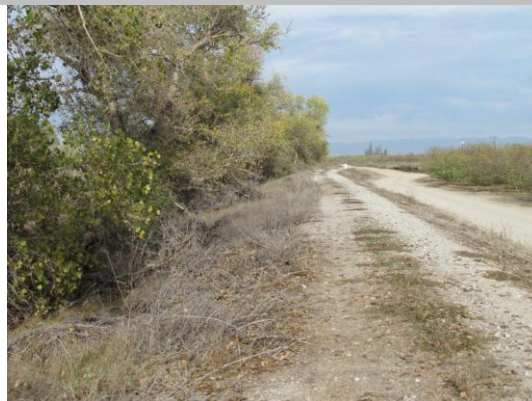
Photo 1 of 1 : FA_2014_NA0011_143_34_20141124_00015.jpg

| Control annual grass and weeds on the levee slopes and easements. Inspector Comments: Remove the wild growth from the waterside. | | | | | |

Wild growth on the waterside levee slope.

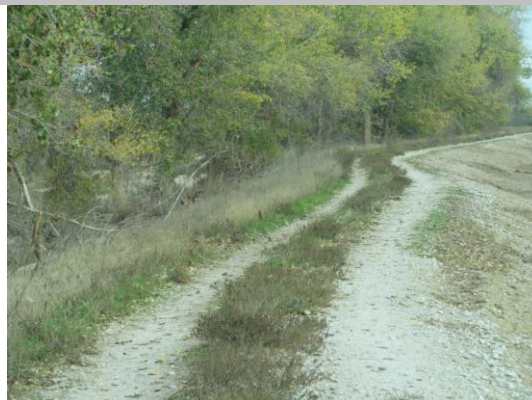
Photo 1 of 1 : FA_2014_NA0011_143_44_20141124_00017.jpg

| Inspector Comments: Keep crown roadway free of vegetation. | | | | | |

Crown roadway from 0.98 to 1.40 tall grasses present.

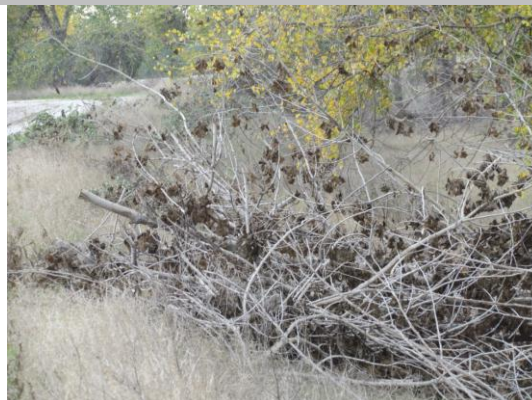
Photo 1 of 1 : FA_2014_NA0011_143_43_20141124_00018.jpg

Dead fallen tree not removed from levee section, reported in Spring inspection.

| Trim and thin trees to allow visibility of the ground and room to flood fight. | | | | | |

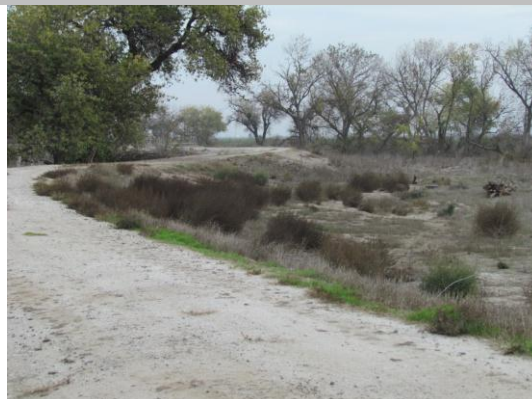
Photo 1 of 1 : FA_2014_NA0011_144_1_20141124_00012.jpg

| Inspector Comments: Remove the tumble weeds from the levee section. | | | | | |

Looking upstream from levee mile 0.00 tumble weeds present on the waterward levee section.

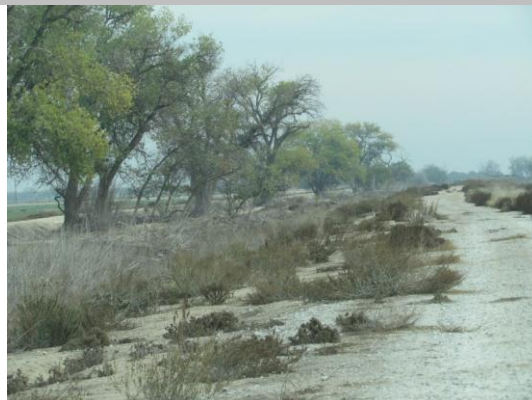
Photo 1 of 1 : FA_2014_NA0011_144_36_20141124_00013.jpg

| Control annual grass and weeds on the levee slopes and easements. Inspector Comments: Control the unwanted wild growth from the landward levee section. | | | | | |

Looking upstream at levee mile 0.37 wild growth covering the landward levee section to the levee mile 1.55.

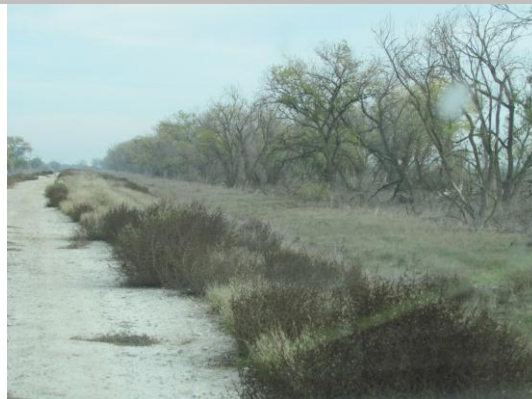
Photo 1 of 1 : FA_2014_NA0011_144_40_20141124_00009.jpg

| Inspector Comments: Remove the unwanted tall weeds from the waterside levee section. | | | | | |

Unwanted tall weeds on the waterside shoulder and slope.

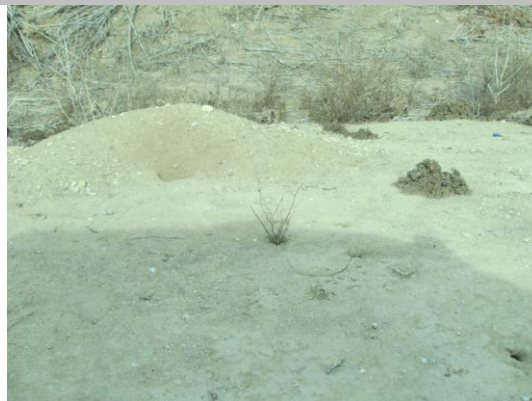
Photo 1 of 1 : FA_2014_NA0011_144_41_20141124_00014.jpg

| Inspector Comments: Need bait stations present where rodents are active. | | | | | |

Large rodent mounds on the landward levee slope.

| Repair the levee slope damaged by livestock and prevent large animal access. | | | | | |

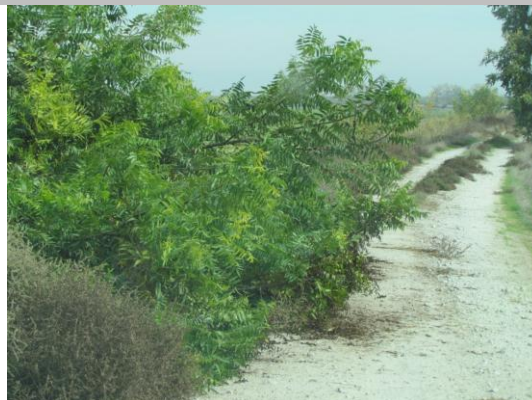
Photo 1 of 1 : FA_2014_NA0011_144_47_20141124_00010.jpg

| Inspector Comments: Control the woody tree growth so the levee slope can be seen. | | | | | |

Woody tree growth completely blocking the levee slope, toe and portion of the crown roadway.

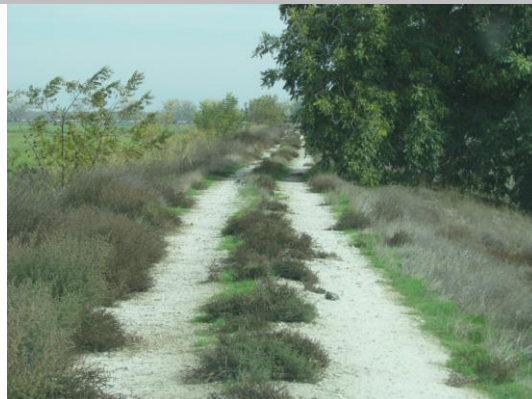
Photo 1 of 1 : FA_2014_NA0011_144_44_20141124_00015.jpg

Looking upstream from levee mile 1.06 to levee mile 1.54 crown roadway overgrown with tall weeds.

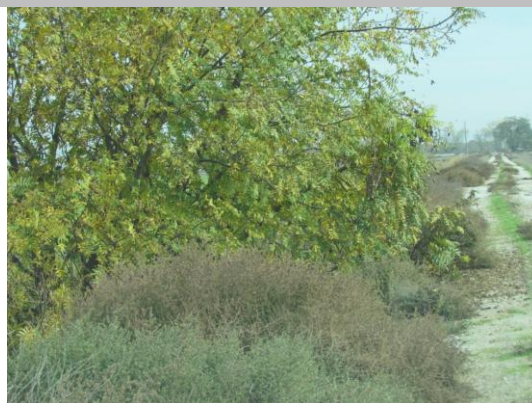
Photo 1 of 1 : FA_2014_NA0011_144_17_20141124_00016.jpg

Looking upstream landward levee mile 1.26 tree growth blocks slope, shoulder and portion on the crown roadway.

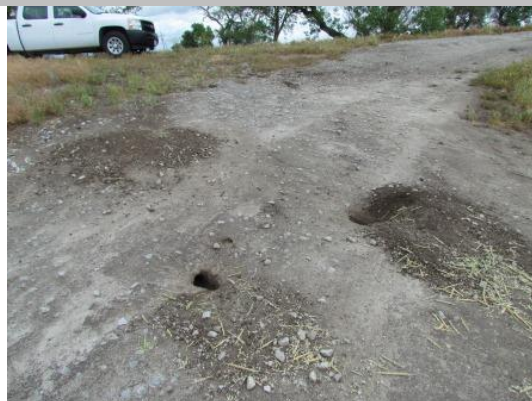
Photo 1 of 1 : FA_2014_NA0011_145_2_20141008_00002.jpg

Large rodent holes on landside slope looking upstream from levee mile 0.01. Photo taken 4-24-2014. No new photo taken no maintenance has been done Fall 2014.

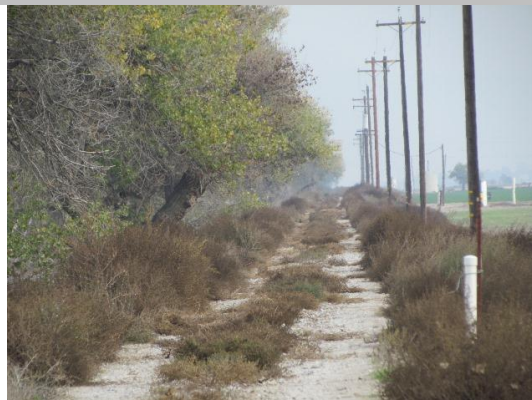
Photo 1 of 1 : FA_2014_NA0011_145_1_20141125_00014.jpg

Berenda Slough looking downstream from levee mile 0.01 to mile 1.52
Tumble weeds taller than 3.0 feet present shoulder slope and toe.

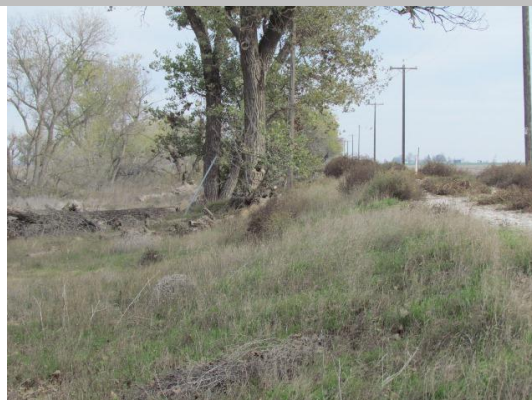
Photo 1 of 1 : FA_2014_NA0011_145_4_20141125_00015.jpg

| Inspector Comments: No maintenance has been done in several years, the weeds are 3.0 feet tall. The condition of the levee slopes can't be seen through wild weeds. | | | | | |

Unsatisfactory wild growth on the water side slope and shoulder.

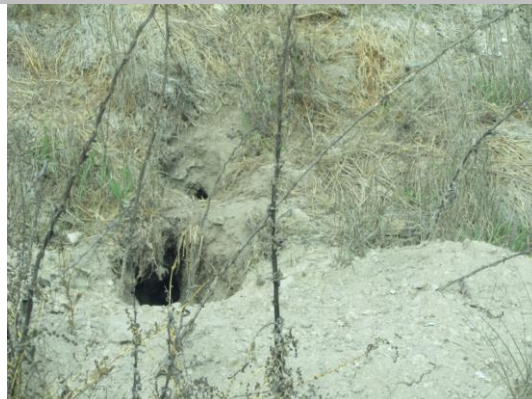
Photo 1 of 1 : FA_2014_NA0011_145_23_20141124_00013.jpg

Rodent mounds present on levee slope levee mile 1.08 to 2.20.

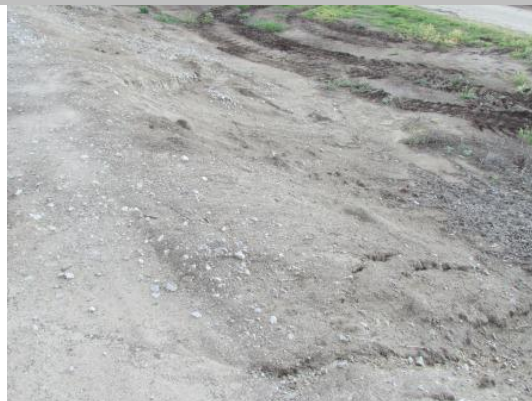
Photo 1 of 2 : FA_2014_NA0011_145_9_20141008_00003.jpg

| Repair slope instability. Inspector Comments: The Madera County Resource Management Agency will be sending the landowner a letter addressing this damage. The damage here was caused by a Contractor. 11-01-2012 no repairs have been done to this site. 4-16-2013 this site was inspected and no repairs has been by landowner. Fall 2014 no change. | | | | | |

Levee mile 1.51 levee damaged by the landowner. Photo taken 4-24-2014.

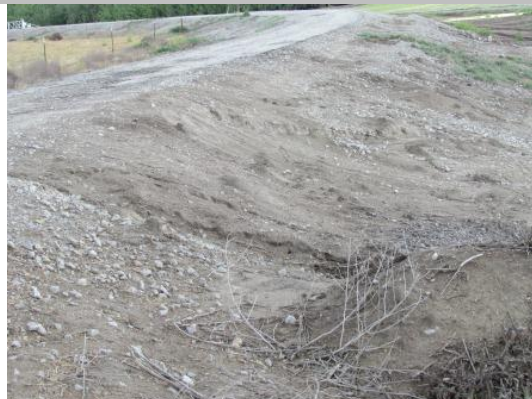
Photo 2 of 2 : FA_2014_NA0011_145_9_20141008_00004.jpg

Levee mile 1.51 landward slope remains unrepaired by the landowner. Photo taken 4-24-2014. No new photo taken Fall 2014. no change.

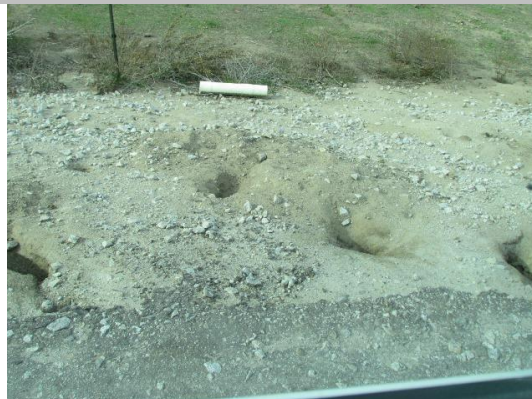
Photo 1 of 1 : FA_2014_NA0011_145_30_20141125_00017.jpg

Berenda Slough looking downstream from levee mile 1.65 waterside
large rodent holes on slope.

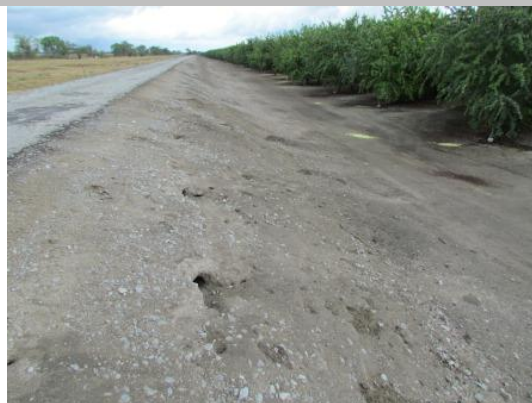
Photo 1 of 1 : FA_2014_NA0011_145_57_20141008_00011.jpg

There are several rodent holes covering the landward slope. Photo
taken 4-24-2014. No new photo Fall inspection 2014.

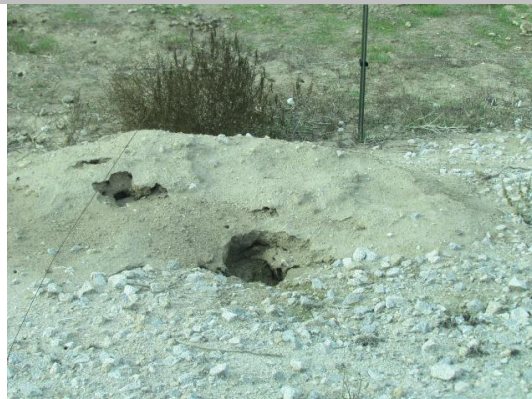
Photo 1 of 1 : FA_2014_NA0011_145_13_20141125_00018.jpg

Looking at waterside upstream from levee mile 1.66 to levee mile 2.25 large holes present on the waterside slope and toe.

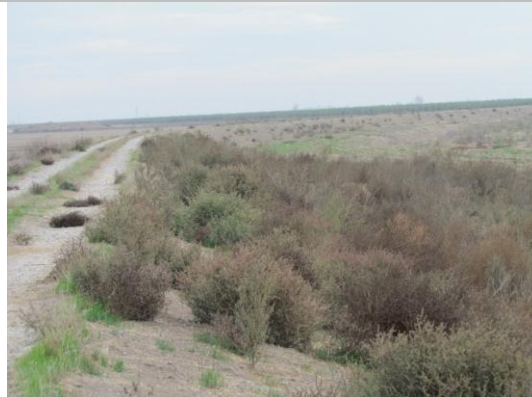
Photo 1 of 1 : FA_2014_NA0011_146_31_20141121_00013.jpg

Looking downstream from levee mile 0.22-0.32 unwanted tall tumble weeds covering waterward levee slope.

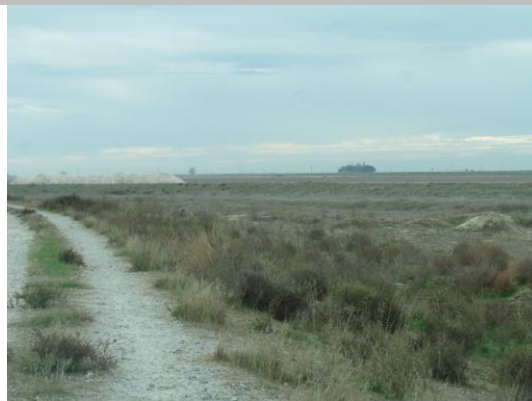
Photo 1 of 1 : FA_2014_NA0011_146_39_20141121_00014.jpg

Looking downstream from levee mile 1.09 to 4.10 tumble weeds covering water ward slope.

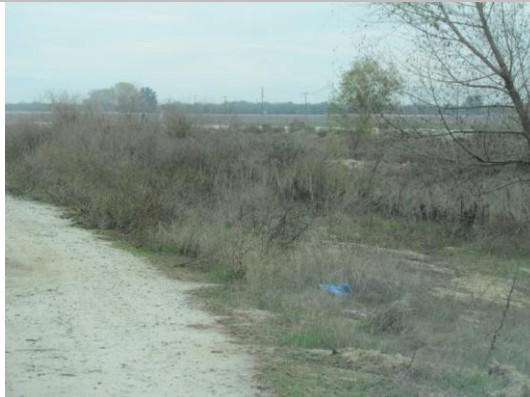
Photo 1 of 1 : FA_2014_NA0011_146_34_20141121_00015.jpg

Looking downstream from levee mile 6.64 unwanted wild vegetation growth on the waterward shoulder and slope.

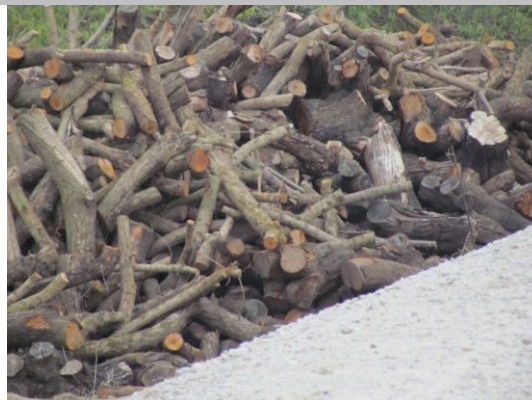
Photo 1 of 1 : FA_2014_NA0011_146_28_20141121_00016.jpg

Looking downstream from levee mile 8.47-8.50 firewood on the landside levee slope and toe.

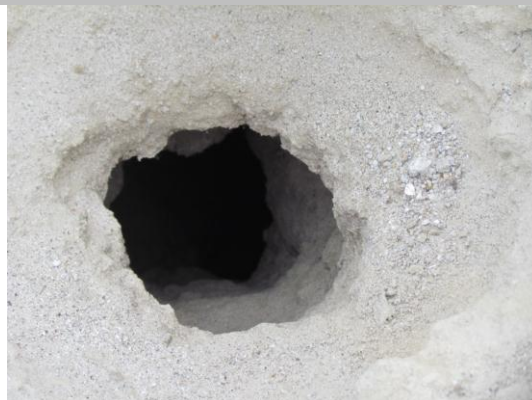
Photo 1 of 1 : FA_2014_NA0011_147_48_20141125_00023.jpg

Huge Rodent hole in crown roadway.

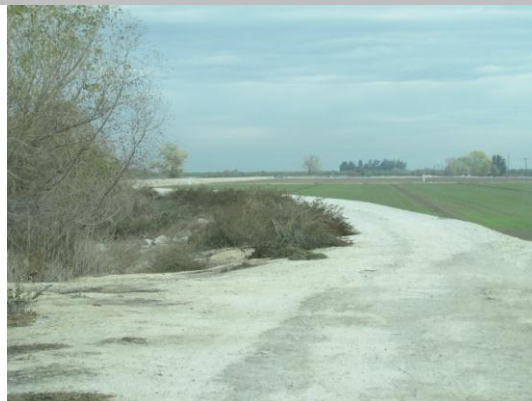
Photo 1 of 1 : FA_2014_NA0011_147_50_20141121_00015.jpg

Looking upstream from levee mile 6.60 to 8.71 unwanted tall brush on the waterward levee slope and shoulder.

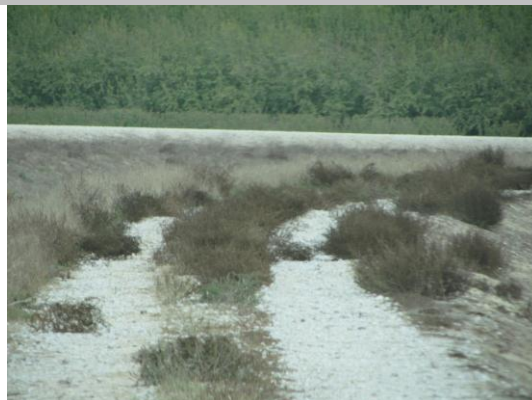
Photo 1 of 1 : FA_2014_NA0011_147_10_20141121_00021.jpg

Looking upstream at wild growth on the crown roadway.
